**RESEARCH AND DEVELOPMENT TESTING
OF YTTRIA/RARE EARTH
STABILIZED ZIRCONIA MATRIX BRICKS
IN THE PILOT TEST UNIT (PTU) AT AEDC**

C. R. Tinsley

ARO, Inc.

November 1972

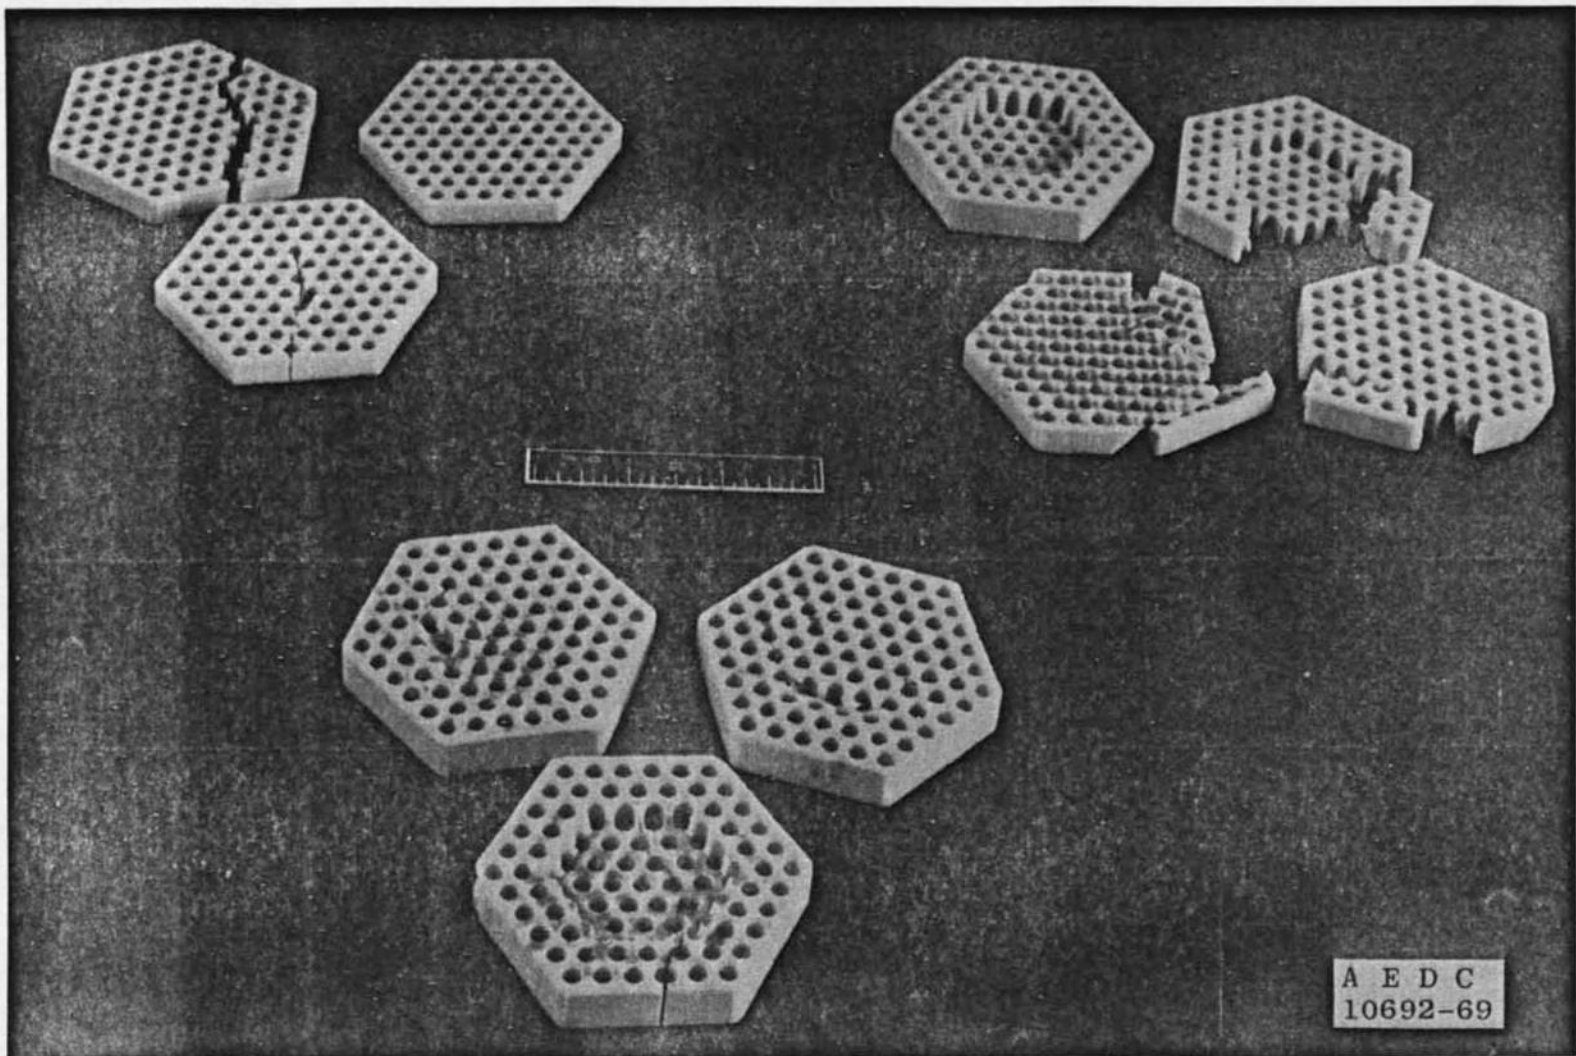
a. Buffer Bricks, Coors
Fig. 10 Post-Run 32 Inspection

Inspection of the matrix revealed that excessive fracturing and cracking had occurred as a result of the reactant flow anomaly. Of particular note was the tendency of relatively long bricks to fracture into shorter segments. All matrix bricks inspected including the original cored bricks were hard indicating no destabilization. Pertinent photographs taken during the inspection are presented in Fig. 10.

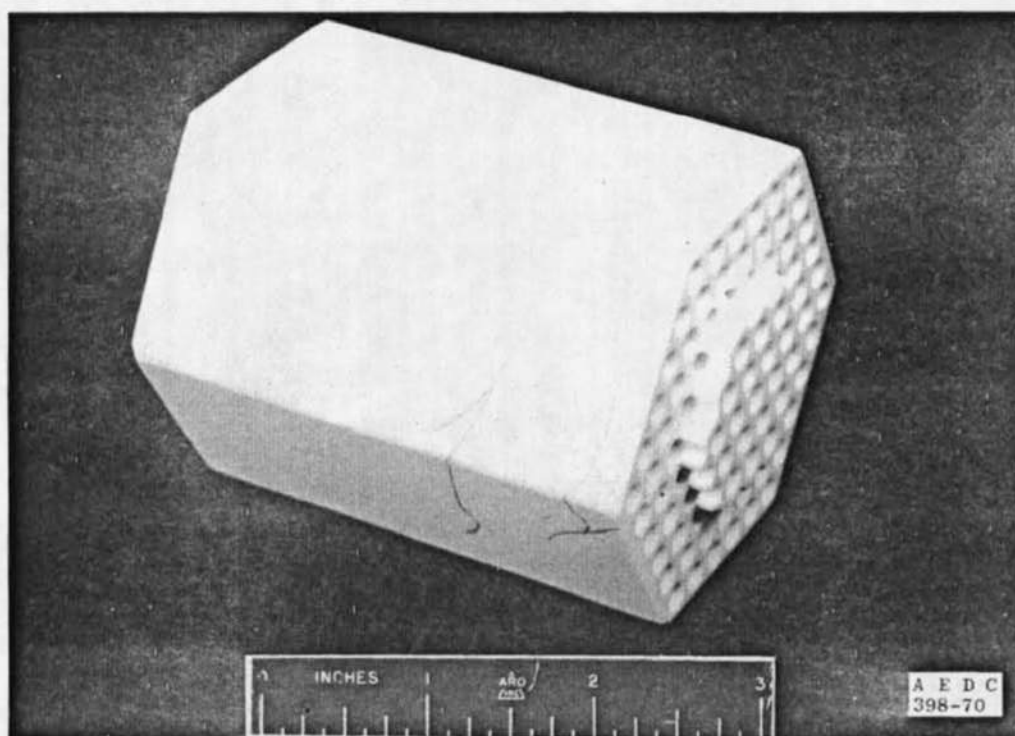
b. Column 8, 12.6 w/o, Coors

Inspections after run 37 revealed (1) that the sample matrix bricks installed before run 33 were in good condition with some hairline cracking and (2) that heater combustion chamber insulation refractories exhibited further degradation. Pertinent photographs taken during the inspection are presented in Figs. 12 and 13.

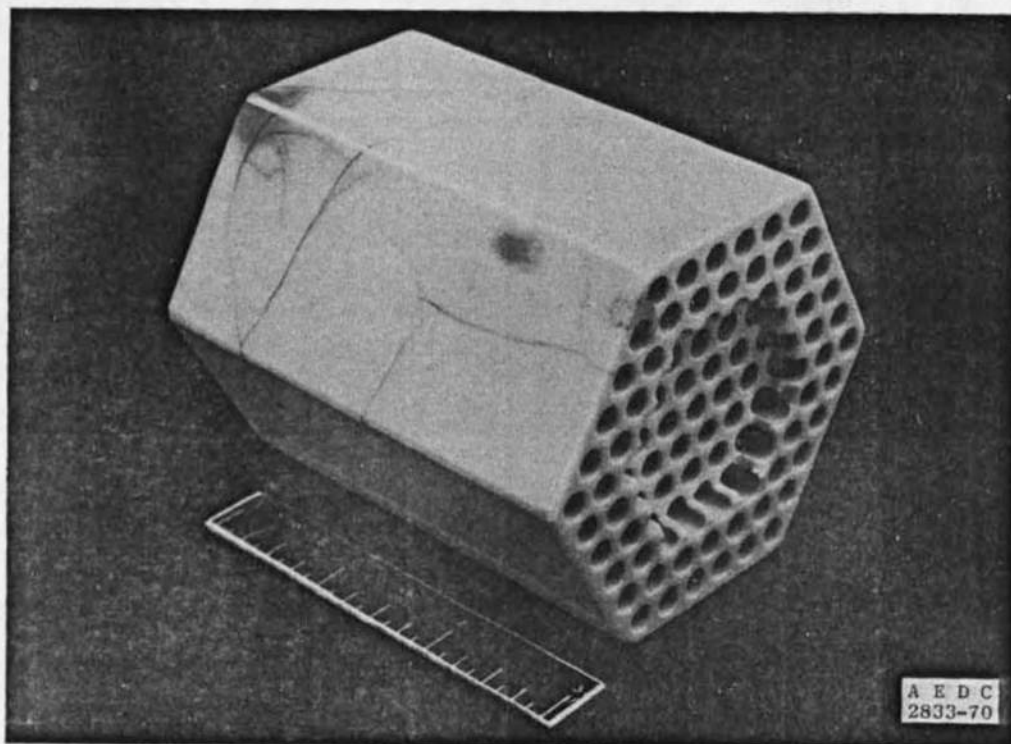
b. Column 8, 12.6 w/o, Coors

Posttest 38 inspections revealed (1) that nitric acid erosion was the prime factor causing burner deterioration and (2) that selected matrix bricks inspected were in good condition with only a few additional hairline cracks. Pertinent photographs taken during the inspections are presented in Fig. 15. The bricks depicted in Figs. 15a and b were also photographed after run. 37 (see Fig. 12) so that the effects of testing could be documented in typical matrix bricks.

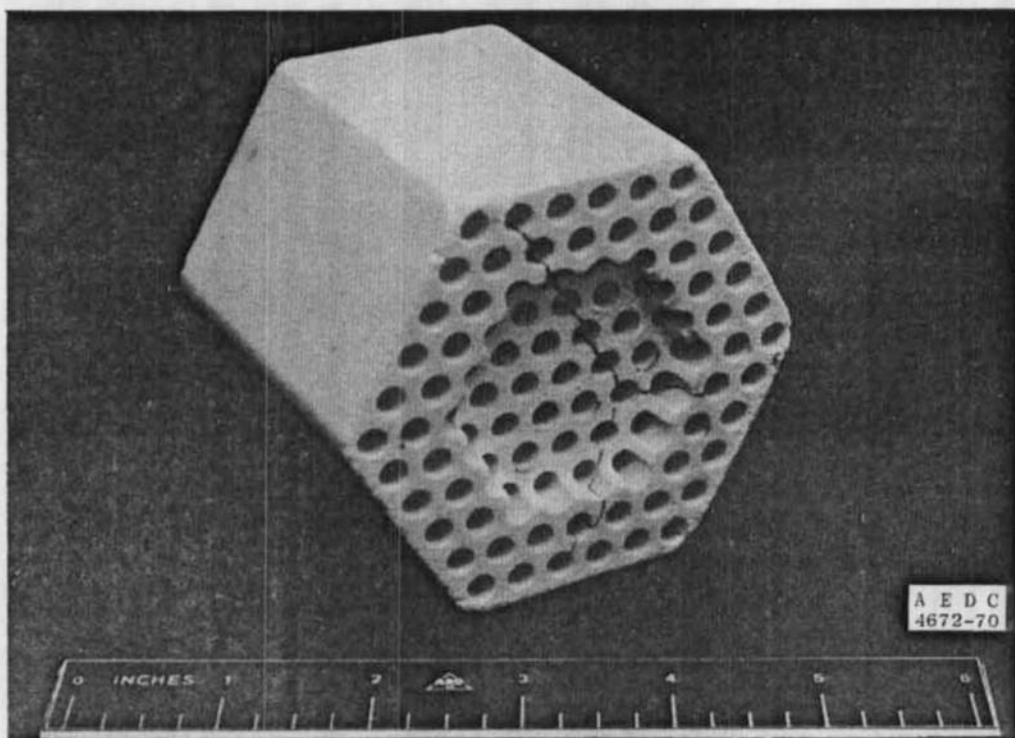
a. Zircoa, Low Density, 12.5 w/o, Upper Block
Fig. 16 Post-Run 39 Matrix Inspection

Inspection of selected matrix bricks revealed them to be in good condition and practically unchanged since inspected after test 38. Pertinent photographs taken during the inspection are presented in Fig. 16. The matrix bricks presented in Fig. 16 were also photographed after test 38 (Fig. 15).

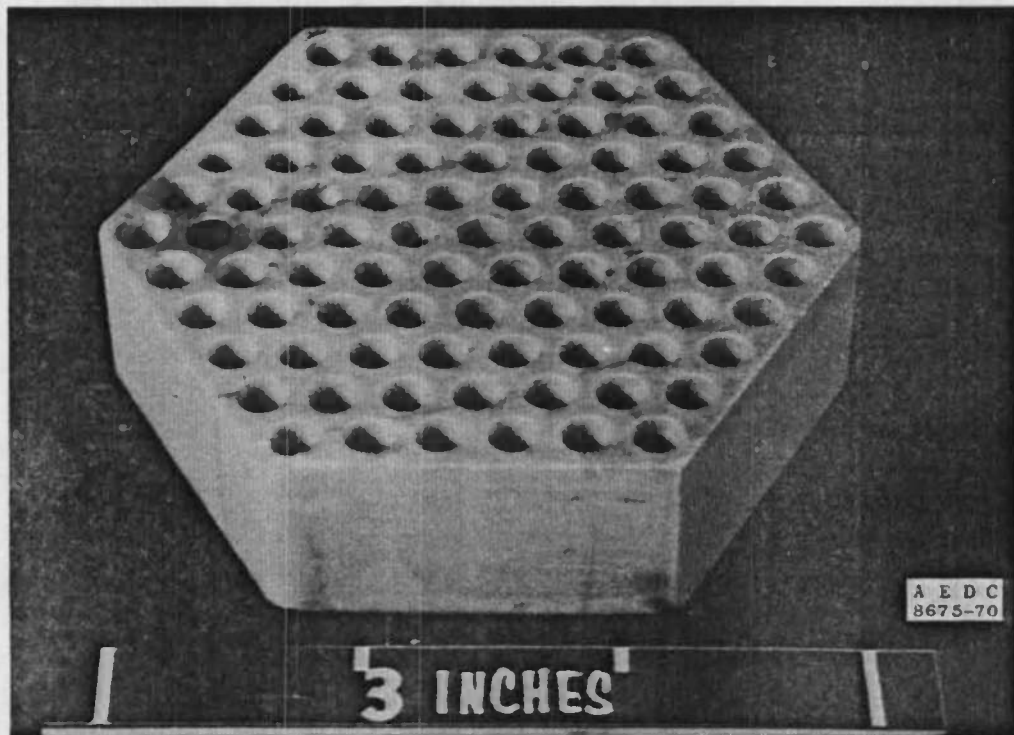
d. Zircoa, 10.8 w/o, Location 14-3
Fig. 19 Continued

Presented in Fig. 19 are photographs typical of the various high density bricks removed from the heater for inspection. It may be noted that practically all cracks are in the vertical (longitudinal) direction.

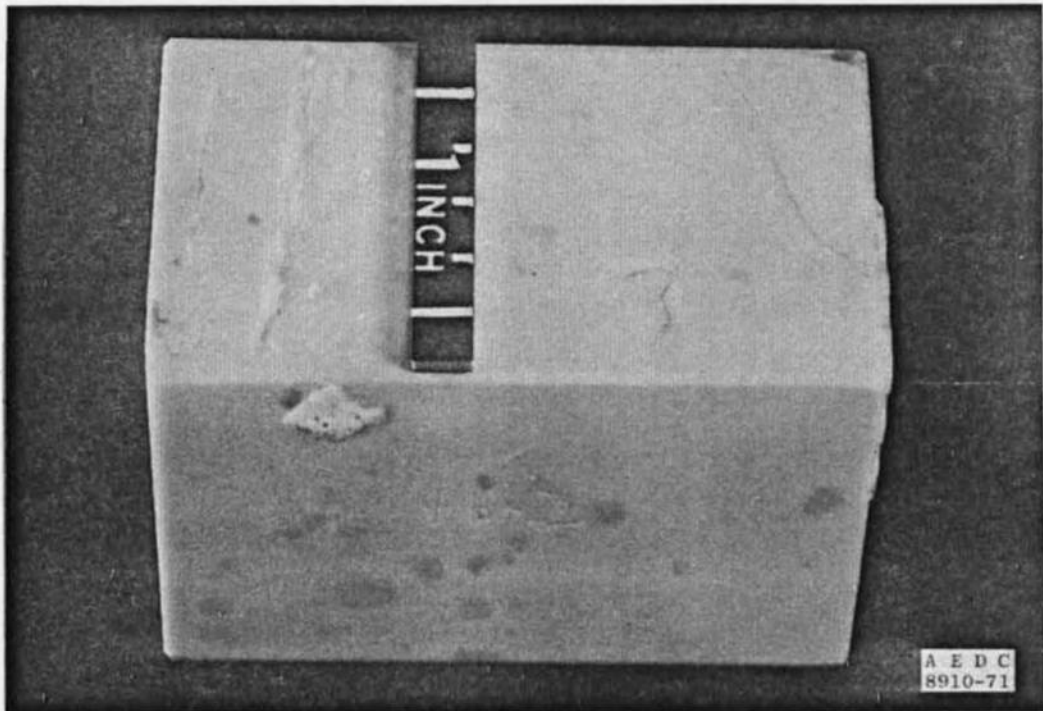
a. Side "A"

Fig. 29 Matrix Brick Exhibiting Stress Marks, Post-Run 44

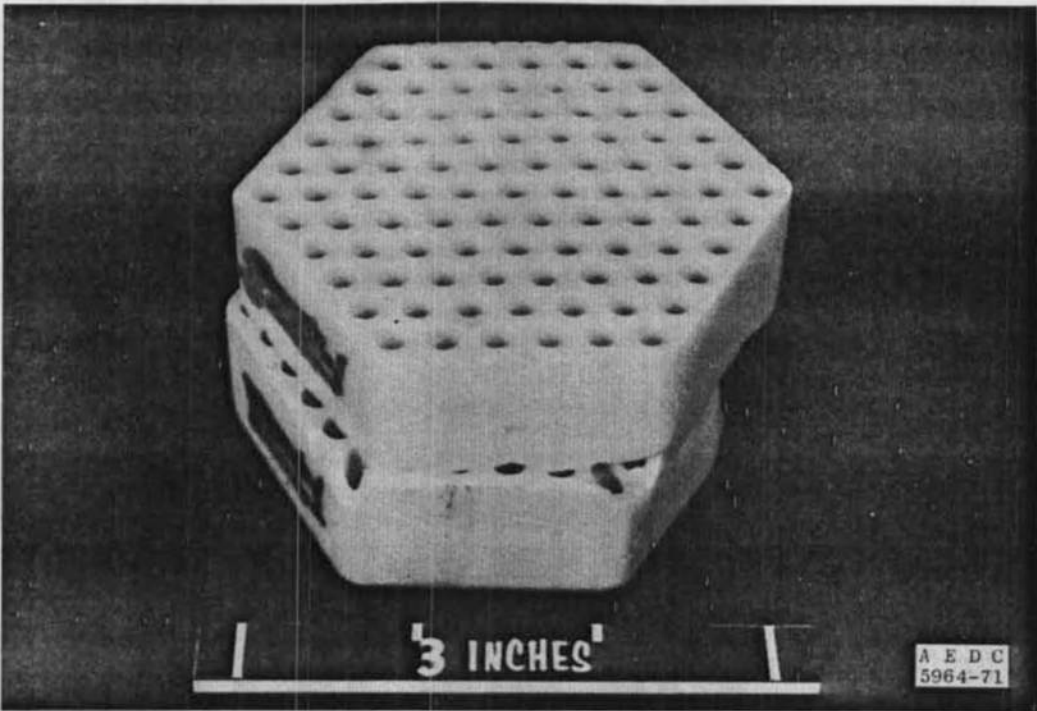
Fig. 30 Misalignment in Non-Keyed Bricks, Post-Run 85

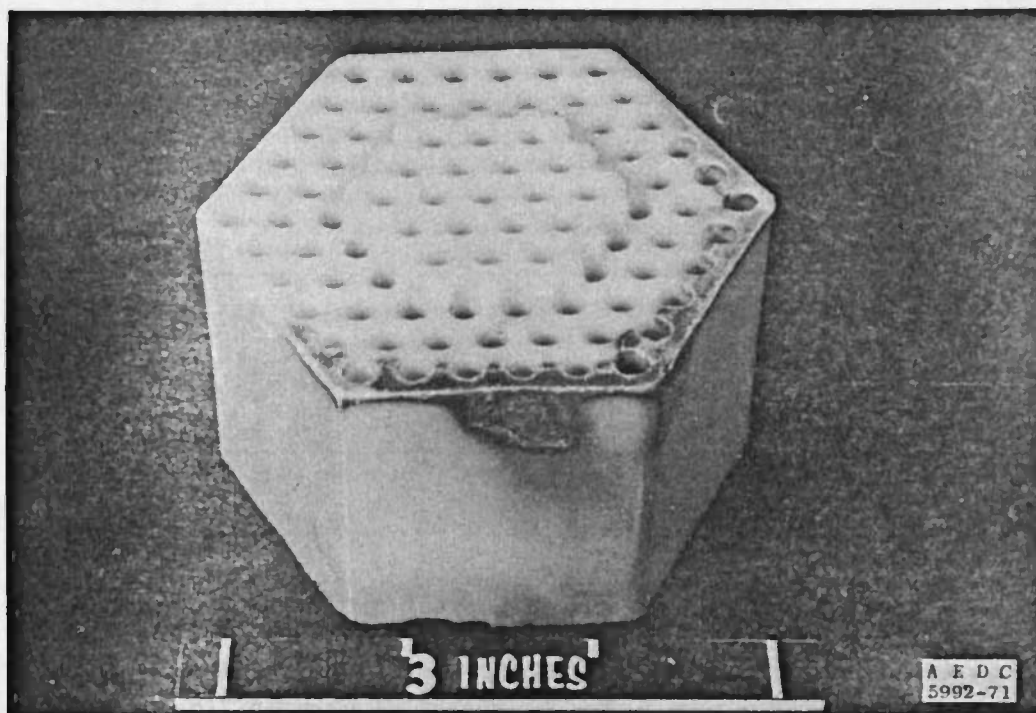
b. Zircoa, 10.8 w/o, Location 13-6

Fig. 31 Bricks Exhibiting Localized Fusion and/or Material Deposits, Post-Run 85

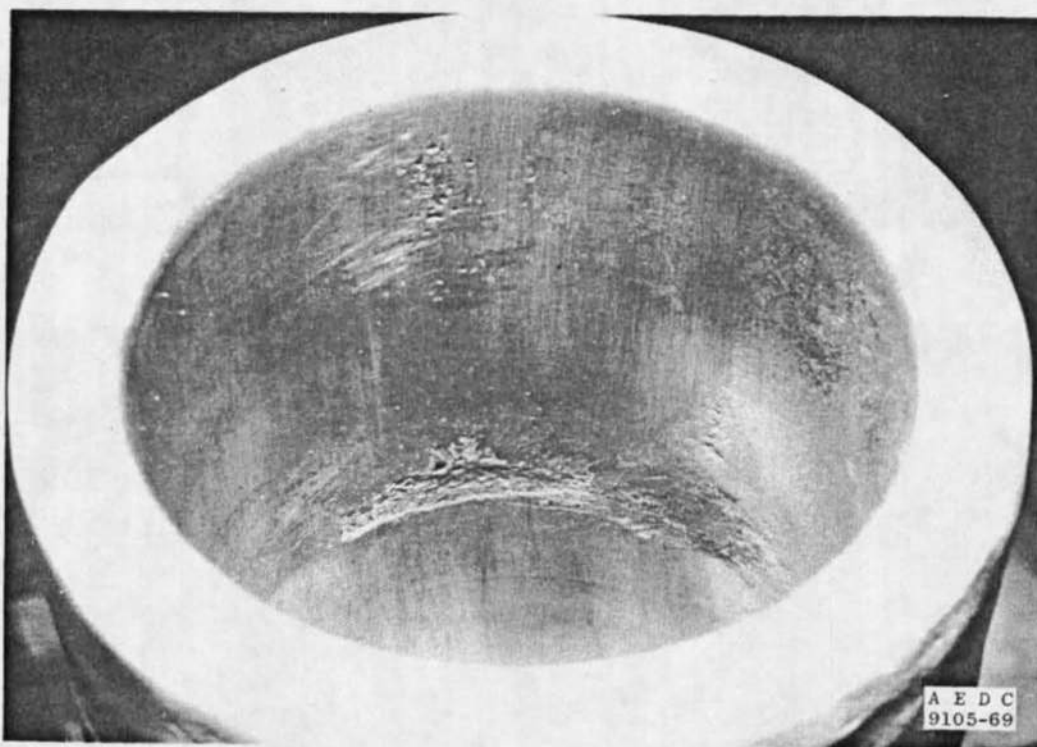
a. Post-Heat Soak

Inspection of the burner revealed severe erosion of the combustion chamber. Details of this inspection and other burner inspections during the test program are provided in Appendix V.
